Advances in Coring Procedures of Silicon Photovoltaic Modules

Helio Moutinho, Bobby To, Dana Sulas-Kern, Chun-Sheng Jiang, Mowafak Al-Jassim, and Steve Johnston

To be presented at the 47th IEEE Photovoltaic Specialists Conference (PVSC 47)

Conference Paper
NREL/CP-5K00-76842
June 2020

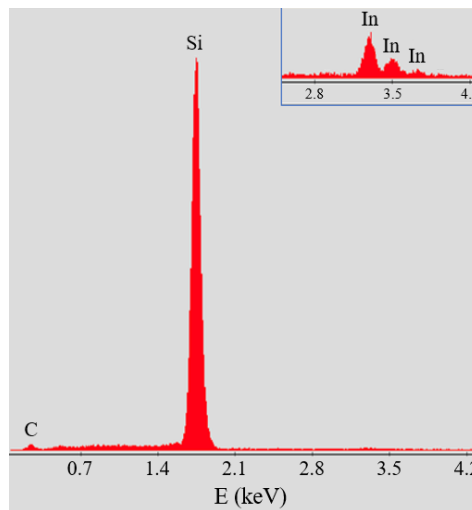
Fig. 2. EDS analysis of the back of the cored cell showing that the ITO layer was removed during the mechanical removal of TPT and EVA. The inset (top right) shows the In peaks of the ITO layer on the front of the cored cell.

We started by applying the standard procedure, and there was not enough precision to remove the TPT and EVA while preserving the Ag lines, as was visually clear. Further EDS analysis (Fig. 2) showed that the thin ITO layer was also removed during this process, as well as part of the Si on the back. Preserving a thin layer of about 100 nm is very difficult, and most of our attempts—such as applying temperature to soften the EVA layer—failed because they require applying hundreds of degrees to the solar cell material, which could induce changes, such as diffusion of impurities. After many experiments, we were able to develop two new coring methods that preserved the back ITO layer.

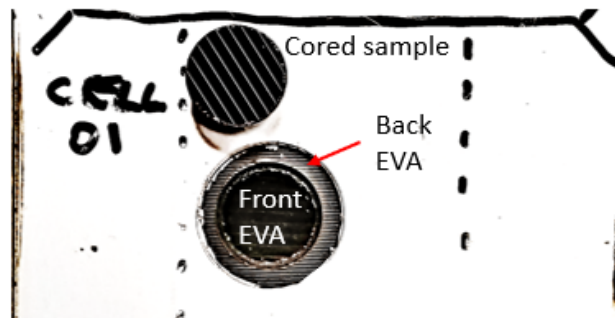
Fig. 3. Back of a cored HIT module showing the initial larger cored area, with the back EVA still in the module; the cored area, with the front EVA at the center; and the cored sample.

The first method required designing and fabricating much thinner metallic stubs that could fit into the chamber of analytical equipment, such as an SEM. Initially, we cored the module until we just touched the back EVA, on a larger area than desired for the final cored sample (Fig. 3); then we applied a large-diameter stub (1") with adhesive directly onto the TPT.

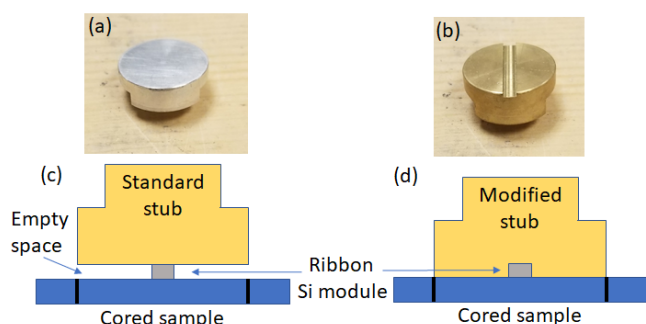
Fig. 4. (a)(b) Standard sample holder and new design, respectively; (c)(d) Configuration of the standard and new setup for stub attachment to the sample, respectively.

the ribbon on the back of the PV module. In the standard procedure, when we need to core an area around a ribbon, we simply remove it to make the area flat. Applying the standard procedure without removing the ribbon did not work because after coring, there was a gap between the bottom of the metallic stub and the back contact that was too large to be filled by the adhesive, as observed in Figs. 4(a) and 4(c). The solution for this problem was to design a special metallic stub (Fig. 4b) with a groove to accommodate the ribbon and eliminate the empty space (Fig. 4d).

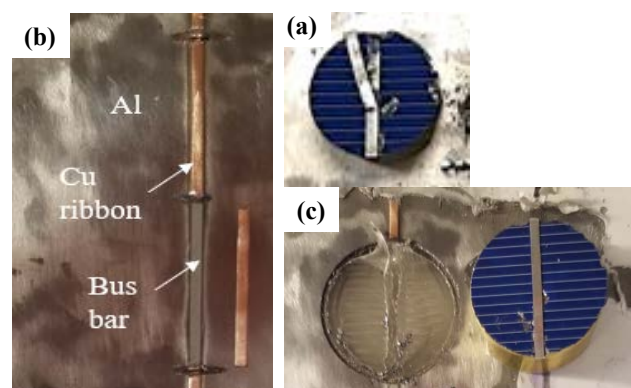
Fig. 5. (a) Cored cell with detached Cu ribbon after removal from the module; (b) Back of the module with cuts at locations to be cored; (c) Back of the module after coring and removal of cored sample.

Coring was performed following the standard procedure. However, many of the front ribbons detached from the cored samples during removal from the module, as observed in Fig. 5(a). Probably, the thick, relatively low-speed coring drill did not completely cut the ductile Cu ribbon in the front of the module, and the Cu ribbon on the cored sample was pulled out by the part of the ribbon that stayed on the module during the sample removal step. Because the module uses tempered glass, a single cut will result in the whole module breaking in thousands of small pieces [6]. To prevent this from happening, we stop coring as soon as the tempered glass is reached—which, in this case, was not enough to completely cut the front Cu ribbon.

The solution for this problem was to use a small, thin, high-speed rotating saw to cut the module from the top of the back Cu ribbon down to the front Cu ribbon on the exact locations where the coring drill was going to cut the ribbons. The rotating saw was stopped as soon as the front EVA was reached and before it could cut the glass. These cuts are observed in Fig. 5(b) from the back of the module. The ribbon is soldered to the back of the module in three places only, and part of it detached from the module after the cuts, as observed in the figure. With the front ribbon cut at the coring position, we resolved the delamination issue.

After these adjustments, and the new metallic stub, we were able to successfully and repeatedly core the module, as observed in Fig. 5(c), which shows a cored area on the module, with the front EVA, and the cored solar cell, with the front ribbon still attached to it.

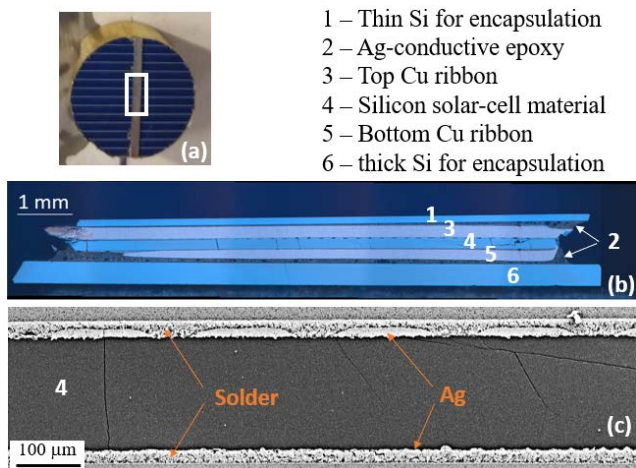
Fig. 6. (a) Silicon sample after coring. (b) Optical microscopy image showing the several layers of the cross section of the cored sample. (c) SEM image of the cross section showing the location of the Ag and solder layers. Cracks extending from the bottom to the top of the Si solar cell are clearly visible.

As mentioned before, the objective of coring this module was to analyze the cross section in the region around the solder location. For this purpose, we needed to protect the solder regions, including the ribbons, during sample preparation. This was accomplished by cutting the cored samples with pliers in the region close to the ribbon and encapsulating and polishing them. The polishing was stopped as soon as the ribbon and solder region were reached, as revealed by an optical microscope. The structure of such a sample is shown in Fig. 6, where we observe the region from where the sample was prepared (a) and the cross section showing the different layers. The cracks observed in the Si cell may or may not have been introduced during coring and are under investigation. The EDS analysis showed a significant amount of Sn in the Ag back and front contacts, compatible with the formation of Ag_3Sn , which has been shown to increase the series resistance of the module [7]. The initial findings of this work have been presented elsewhere [8].

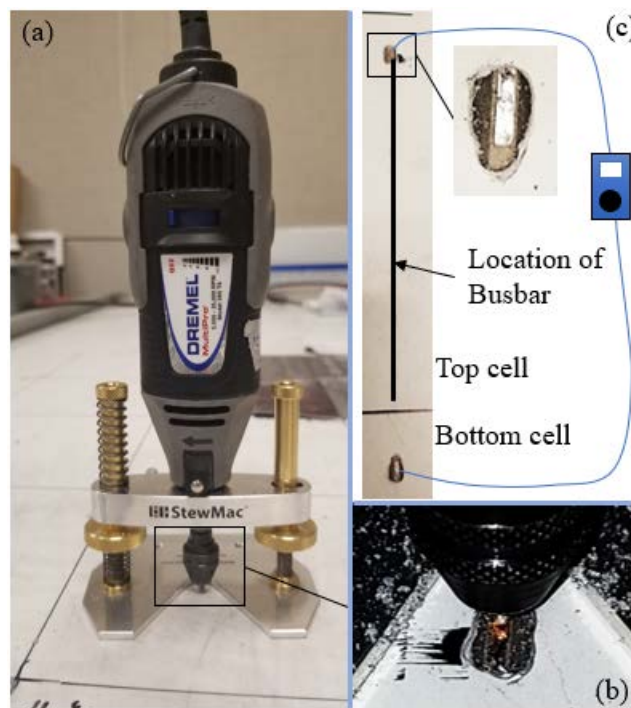
Fig. 7. (a) Configuration of the procedure to make openings on the back of PV modules. (b) Higher magnification showing the removed material. (c) Openings on the module and the measurement schematic.

Finally, we describe a procedure to place small openings at different locations directly over the bus bars, to allow for the measurement of the cell parameters of individual cells on PV modules. For this purpose, we use a special bit installed on a Dremel tool that cuts down into the back of the PV module. Initially, we tried to control the size and depth of the cut by simply holding the Dremel tool, but it proved to be unreliable and often the bit would go deeper than desired. To avoid this problem, we use a special device to hold the drill exactly over the place where the opening will be made. At the same time, the device limits the depth that can be reached by the drill, so there is no damage of the module. The schematic of this procedure is shown in Fig. 7. Several openings were cut on many different locations of individual solar cells in the module described in the previous section. This allowed us to measure efficiency-related

parameters of individual cells, as well as groups of cells, and to study how the power output varied at different locations of the module and how the degradation was distributed. These measurements can identify areas to be cored and allow for the correlation between microscopic and macroscopic properties measured on different locations of the module.
