Silicon Heterojunction Field Performance

Silicon Heterojunction Workshop

Dirk Jordan, D. Kern, S. Johnston, H. Moutinho, CS. Jiang, M. Young, A. Norman, C. Deline, – NREL

10/20/2020

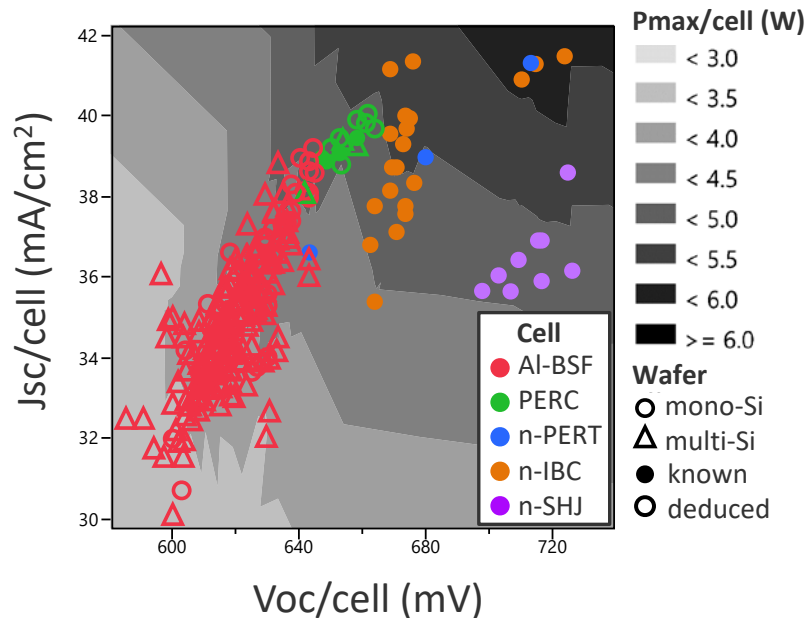
Scale IV parameters to the same number of cells & cell area

Al-BSF: Aluminum back surface field
PERC: passivated emitter & rear cell
PERT: passivated emitter rear, totally-diffused
SHJ: heterojunction
IBC: interdigitated back contact

Can reasonably well identify cell technologies from datasheet entries
(although a few systems in the PERC/Al-BSF transition region may be misidentified)

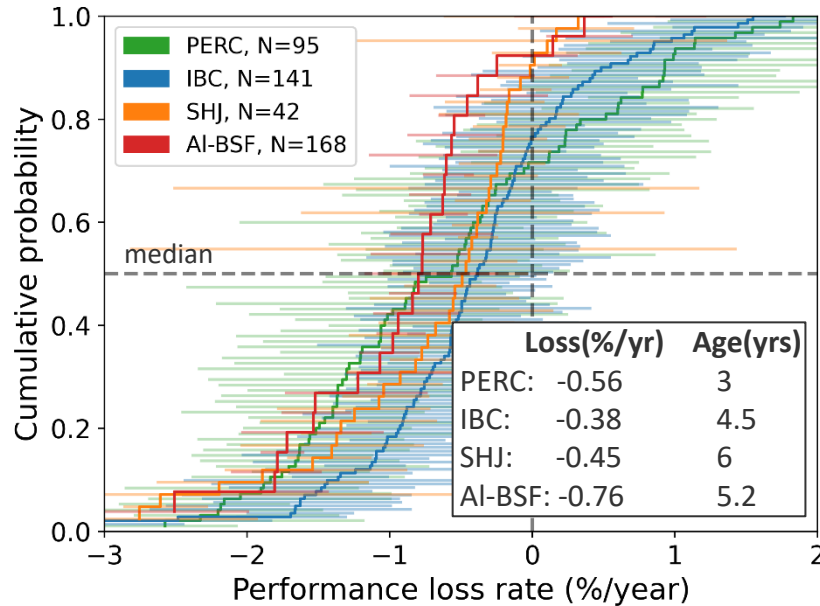
Cumulative distribution function (CDF) of high-efficiency systems

“Degradation rate” can be ambiguous → performance loss rate

Satellite data used for irradiance

At the median, performance loss rates for SHJ, IBC, PERC are at least as good as AI-BSF

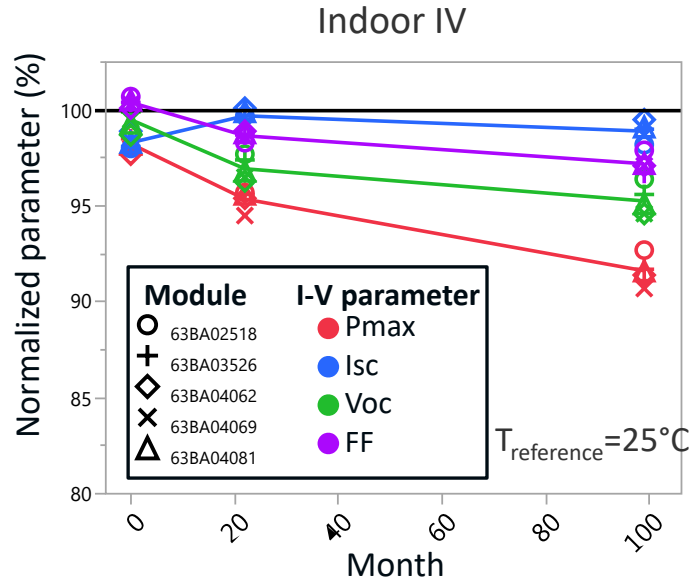
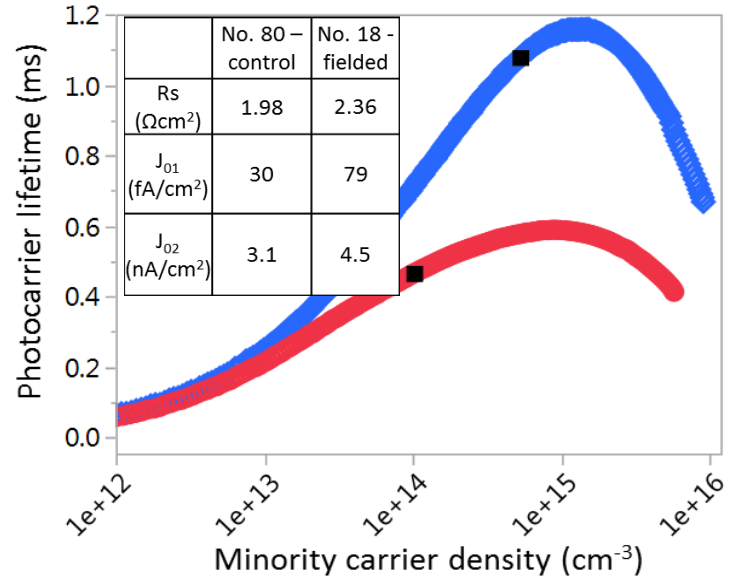
SHJ NREL installation: Nonlinear decline in V_{oc}

Installed: 2007
 Size: 1kW, 5 modules
 Age: 10 yrs
 Mounting: ground

Voc: most of the decline in first 2 years
FF: small decrease, R_s increase (no solder bond problems, corrosion, cell breakage)
Isc: within measurement uncertainty

Degradation 0.4-0.6 %/year range, within warranty

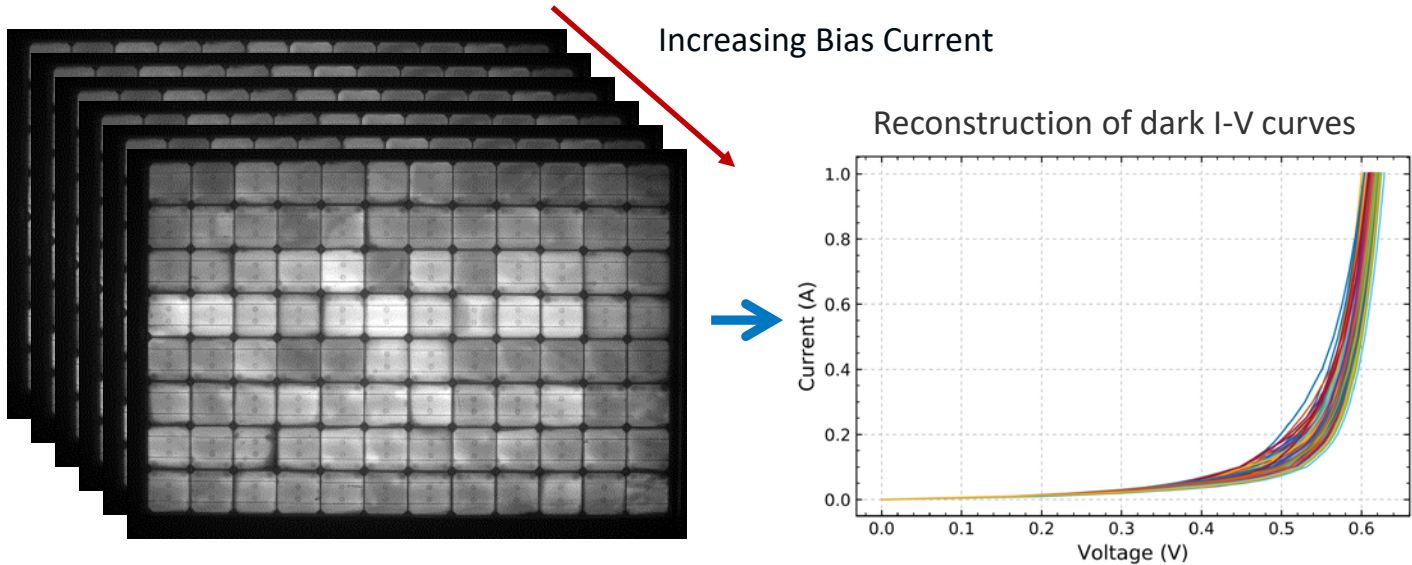
Take images under a range of bias currents
($<10\% I_{sc} - I_{sc}$)

Fit 2-diode model → can map diode parameters for each cell within the module

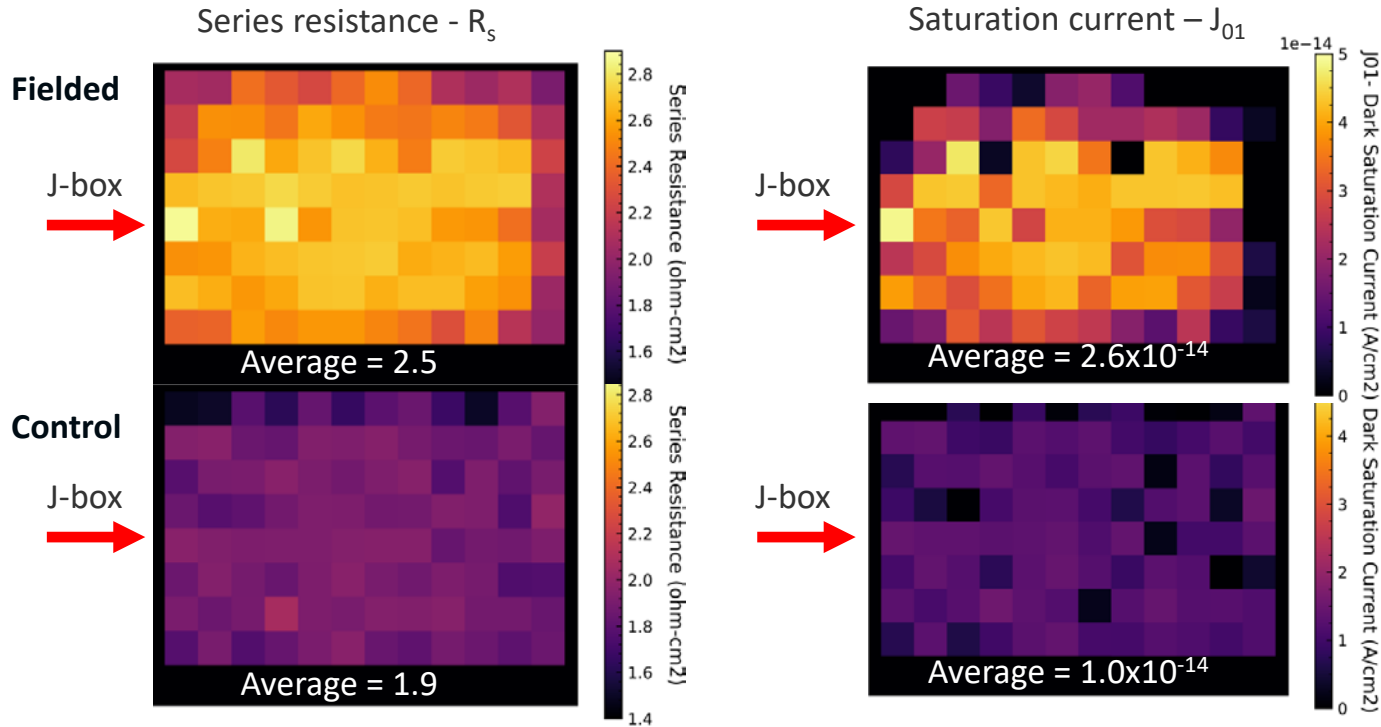
Fairly uniform increase in J_{01} & R_s

Cell over the J-box shows highest increase in J_{01} & R_s \rightarrow temperature may play a role

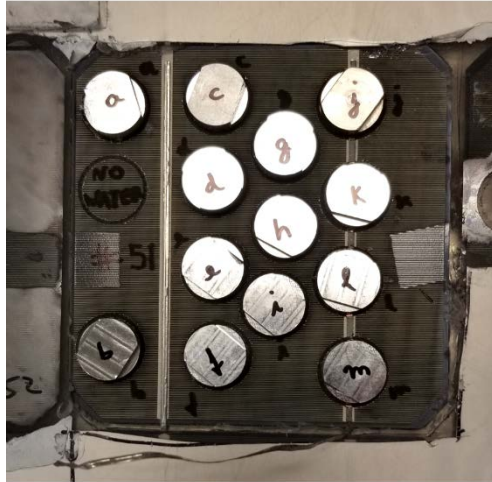
Metal stubs to remove cell pieces

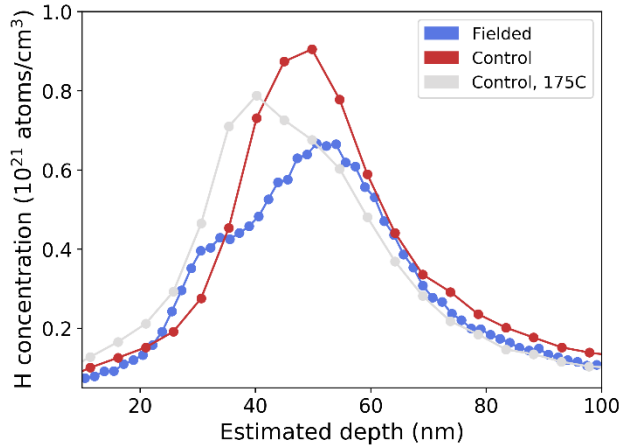
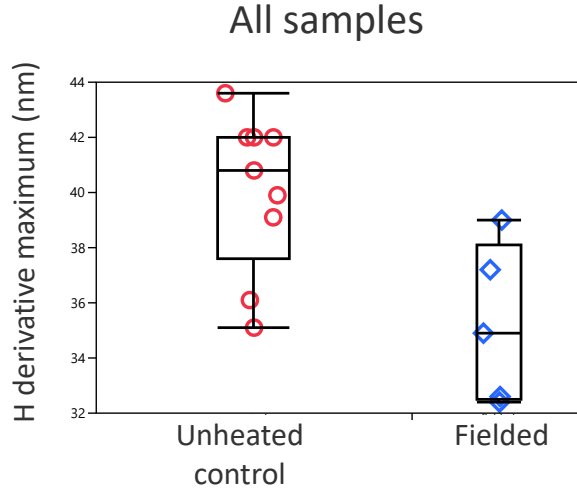
Dynamic secondary ion mass spectroscopy (d-SIMS)

Orientation of samples was close

Statistically significant (though we could use more samples) $p = 0.011$

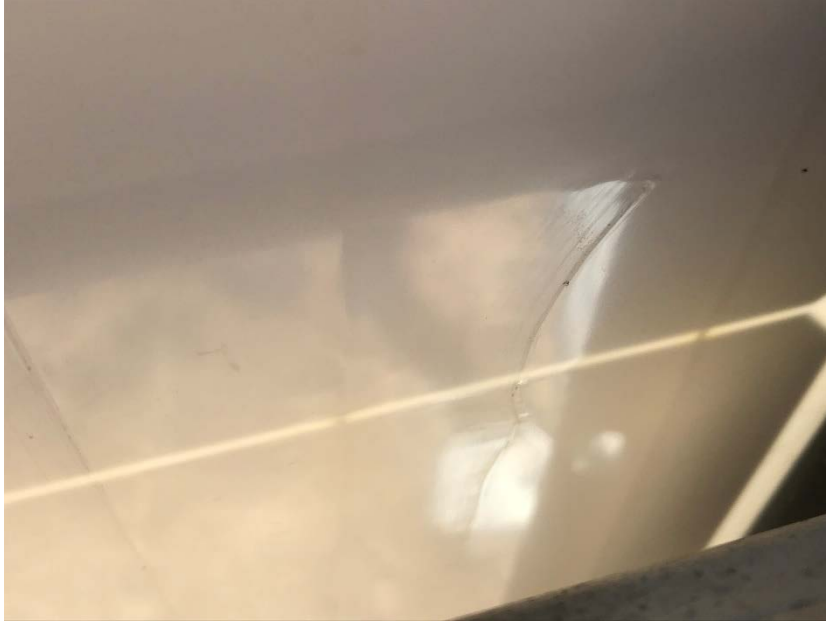
Degrading module

- Back shows a scratch mark
- EL image shows damage to 3 cells

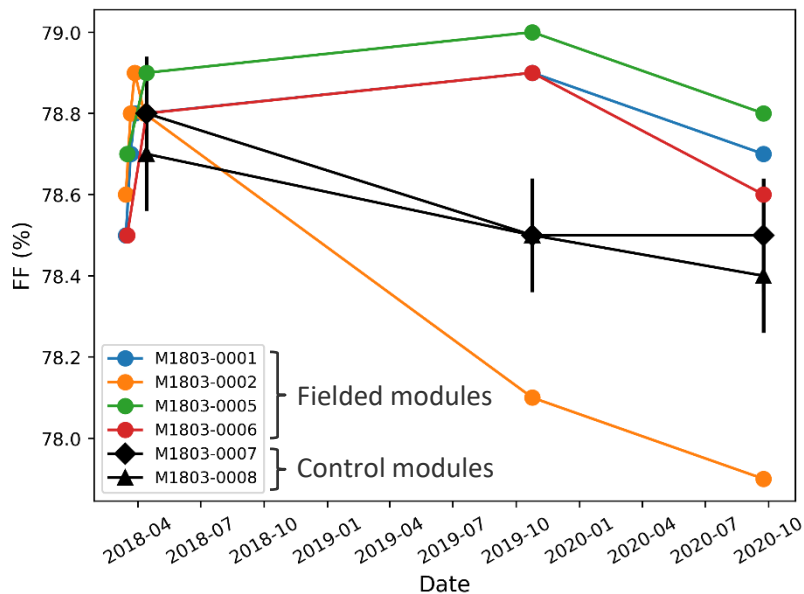
Voc & FF performance

- Voc appears to be degrading, although uncertainty bars are barely overlapping
- Median degradation in 0.3%/year range
- FF appears stable with the exception of the module with scratch (M1803-0002)
