Results of ISO/TS 6336-22 Evaluating Full Contact Zone

Preprint

Presented at American Gear Manufacturers Association 2022 Fall Technical Meeting

Conference Paper
NREL/CP-5000-83100
October 2022

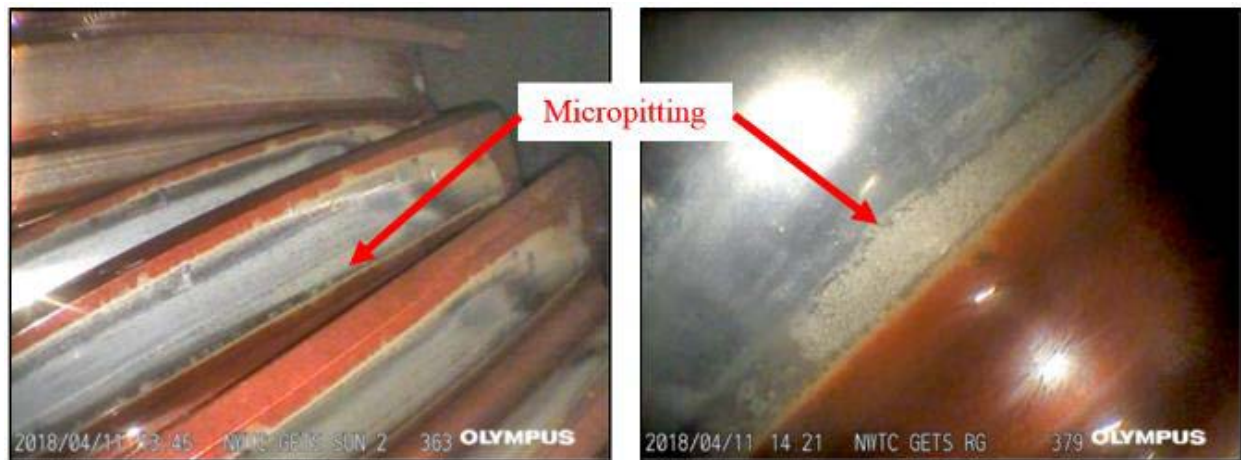
Pictures of the micropitting can be seen in Figure 4. The previous paper also contains pictures of the micropitting and details about the gear drive as documented in [17]. For this paper, all maintenance records were reviewed. In addition, extensive operational data were acquired and analyzed from the turbine’s supervisory control and data acquisition (SCADA) system. Reference [18] is publicly available and contains the full documentation for this information.

Figure 4 - Micropitting on the sun pinion teeth. (Photos by Scott Eatherton, Wind Driven, NREL 61193 and 61194)
