# Evaluation of Surface Crack Formation in Photovoltaic Backsheets Using Fragmentation and Finite Element Simulations

## Preprint

**Conference Paper**  
NREL/CP-5K00-85530  
October 2023

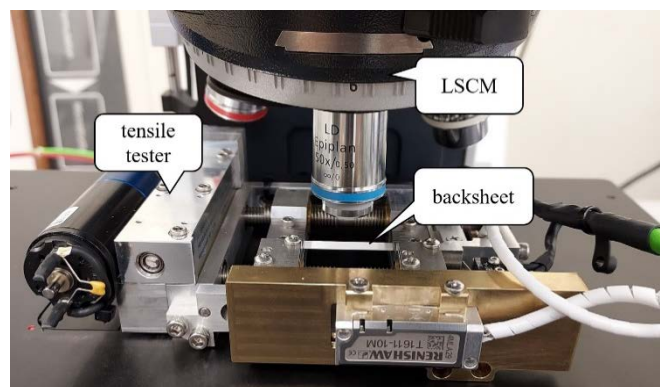
**Fig. 2.** Fragmentation setup with LSCM and mini-tensile tester

After roughly 250 hours of exposure, a sample of each backsheet is extracted. They are potted in epoxy with the cross-section exposed and cut with a microtome (Leica Biosystems Nussloch GmbH, Nussloch, Germany). Young’s Modulus of each layer is evaluated with a G200 nano-indenter (KLA, Milpitas, CA) with a conical  $1 \mu\text{m}$  radius,  $60^\circ$  diamond tip. Additional measurements in the outer layer enable an in-depth evaluation of a possible depth-dependency of the modulus, which can be caused by degradation. The indents are then visualized under a Zeiss model LSM800 (Carl Zeiss Microscopy, White Plains, NY) laser scanning confocal microscope (LSCM), allowing accurate determination of their position. Further samples are cut into 5 mm wide strips for fragmentation testing. They are individually mounted into a mini-tensile tester and imaged through the 50x objective of the LSCM. Tensile testing is performed in a stepwise fashion increasing uniaxial strain on the sample, shown in Fig. 2. At each step, an image of a  $(715 \mu\text{m wide} \times 238) \mu\text{m}^2$  large area is taken, consisting of three  $(238 \times 238) \mu\text{m}^2$  squares. The number of visible cracks is counted to determine the surface crack density. To extract the crack depth, larger surface features are first removed and flattened out using a robust Gaussian filter according to the ISO (International Organization for Standardization) 16610-71 standard [35]. The average crack depth is extracted by evaluating two two-dimensional profiles across this area. To reduce the measurement noise, an integration over three areas normal to the direction of the applied strain is applied to these profiles, with each area being  $(155 \times 155) \text{ nm}^2$ . The maximum crack depth on the sample is extracted by searching for the largest pit depth according to the ISO 25178-607 standard [36].

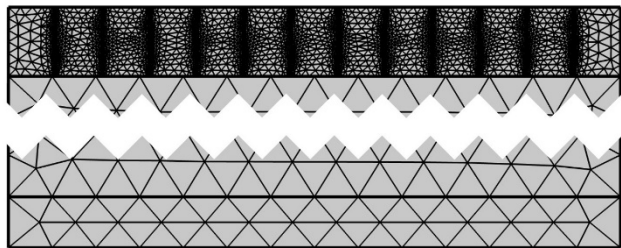
**Fig. 3.** Example simulation mesh for the AAA backsheet, with a possible crack density of up to 38 cracks/mm. The areas with the much finer mesh in the outer layer are adjacent to the decohesion elements.

We add several lines of initially zero-thickness decohesion elements [23] in regular intervals to define possible cracks in the outer layer. The distance between them is set to be in line with the saturation crack density measured in the corresponding fragmentation test. Because only surface crack formation was observed in the experiment, these lines only reach through the outer layer and do not penetrate further into the backsheet. Fig. 3 shows the mesh of the AAA backsheet.

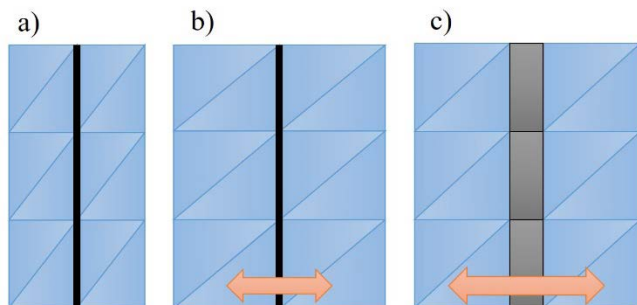
**Fig. 4.** a) Zero-thickness decohesion elements in the unstrained material. b) As the strain increases, the material deforms. However, while the decohesion criterium is not met, the decohesion elements remain at zero thickness. c) After the criterium is met, the decohesion elements grow and split the material, thus a crack begins to form.

A critical stress  $\sigma_{cr,i}$  is defined on each crack  $i$ . An adhesive force causes the decohesion elements to remain at zero thickness until  $\sigma_{cr,i}$  is met. This force is set in a way to not add additional stress or deformation of the material. In general, it can be a tensile stress, a shear stress, or a combination of both. Due to our experiment applying a tensile strain, we only focus on the tensile stress criterion, causing possible opening mode cracks (also called mode I cracks [17]). As soon as the decohesion criterium is fulfilled, the force is set to 0, which causes the decohesion elements to grow and a crack to form. Fig. 4 shows a schematic of this process.

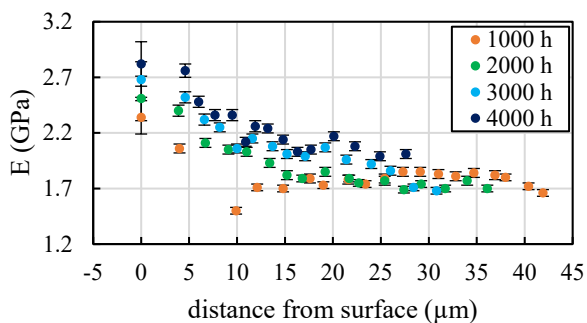
**Fig. 5.** Young’s modulus measured by nanoindentation in the AAA outer layer as a function of the distance to the surface. The measurement at 0 μm is taken on the outer layer surface, not in the cross-section sample. The error bars represent one standard deviation obtained from at least 40 indents for cross-sectional modulus measurements, and at least 15 indents for surface modulus measurements.

The nanoindentation measurements on AAA show that the modulus of the outer layer increases after exposure, but not the core or the inner layer. The change in the outer layer is most pronounced on the exposed surface of the backsheet, seen in **Fig. 5**, with a larger depth affected after longer exposure. This result is in line with previous work on AAA degradation, due to an increase in crystallinity during accelerated aging of AAA. While photo-oxidation and corresponding chemocrystallization are primarily responsible for this increase, thermal processes can also accelerate these reactions [9], [10]. However, the surface morphology does not show any significant changes during exposure as observed under the 50x objective of the LSCM.

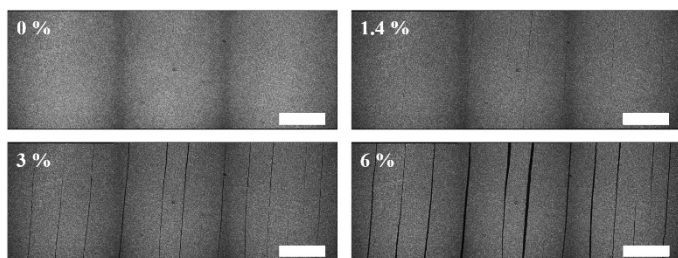
**Fig. 6.** LSCM images of 3000 h exposed AAA surface during fragmentation at various strains. The white scale bars indicate 100 μm length.

No cracks can be observed during fragmentation of the fresh backsheet and of the 250 h-exposed sample. Fragmentation testing of the samples exposed 500 h or longer leads to cracking once a critical strain is applied. Additional strain causes, in general, further cracking until a saturation crack density is achieved. An example after 3000 h of exposure is shown in Fig. 6. At 1.4 % strain most cracks are already open, albeit very shallow and narrow. Further individual cracks form till 2.7 % applied strain. Increasing the strain further, the existing cracks grow wider, however, no new cracks are formed. Both critical strain and saturation crack density are thereby dependent on the time of exposure beforehand and, correspondingly, the degradation status of the backsheets’ outer layer. A longer exposure time correlates with a lower critical strain, i.e., cracks begin to form sooner during the fragmentation test. However, fewer cracks form, leading to a lower crack density, shown in Fig. 7. The error bars of measured crack densities in all corresponding figures show the standard deviation calculated from two or more cross-sections of a fragmentation measurement.

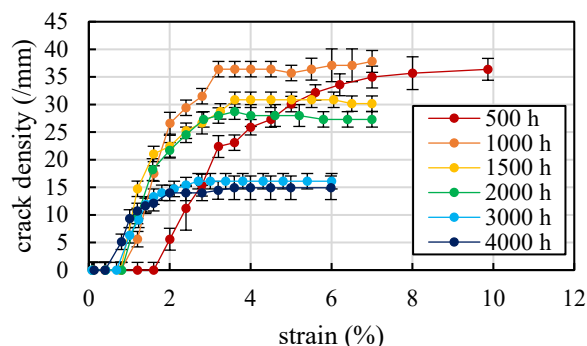
**Fig. 7.** Crack density as a function of strain in AAA after various exposure times. The standard deviation is calculated from at least two measurements on different areas of a sample.

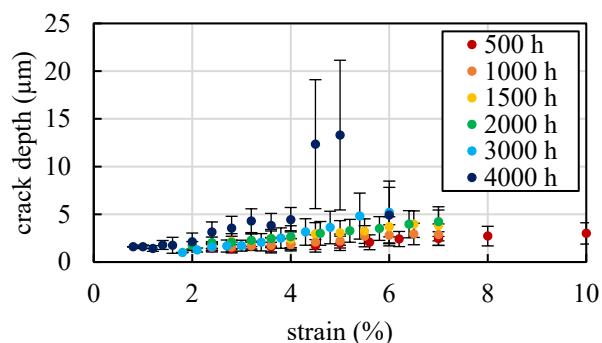
**Fig. 8.** Average crack depth in AAA samples after various times of exposure at increasing strain. The error bars show one standard deviation calculated from the depth of the visible cracks across two profiles.

A longer exposure time results in deeper cracks in strained samples. This result suggests, in combination with the modulus measurements, widening of a brittle region prone to cracking close to the exposed surface due to UV degradation. Increasing the strain causes further crack growth, shown in Fig. 8. It is limited to the outer layer, with one exception. After 4000 h of exposure, strains above 4 % cause several cracks to grow through the entire outer and into the core layer. The maximal crack depth at 4.5 % strain is  $(46.6 \pm 2.0) \mu\text{m}$ . The seemingly lower average crack depth at 6 % strain in this sample is caused by many thin cracks growing so deep, that not enough light is reflected out of them to be detected.

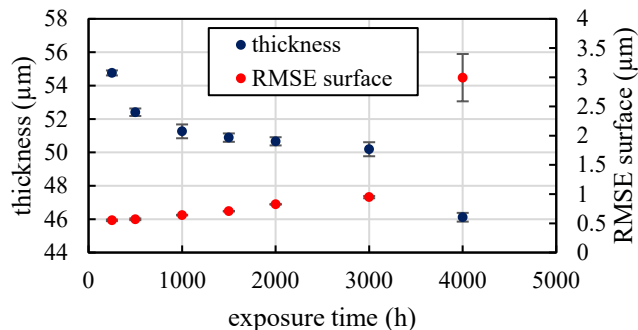
**Fig. 9.** Thickness of the PET outer layer as well as the RMSE of the outer layer surface height in PPE after different exposure times. The error bars of the thickness represent one standard deviation from 15 measurements, and the error bars of the surface RMSE represent one standard deviation from three measured locations.

Compared to the AAA backsheet, the change in modulus of the outer layer of the PPE backsheet after exposure is not significant. However, the loss in thickness and the increase in roughness are more pronounced for PPE as the exposure proceeds (Fig. 9 and Fig. 10), suggesting substantial degradation has occurred in the pigmented PPE outer layer. PET is known to be susceptible to photooxidation and chain scission during UV exposure, which can cause chemical and physical changes of a PET-based backsheet [14], [38]–[40]. The substantial thickness loss ( $\approx 16\%$ ) and roughness increase

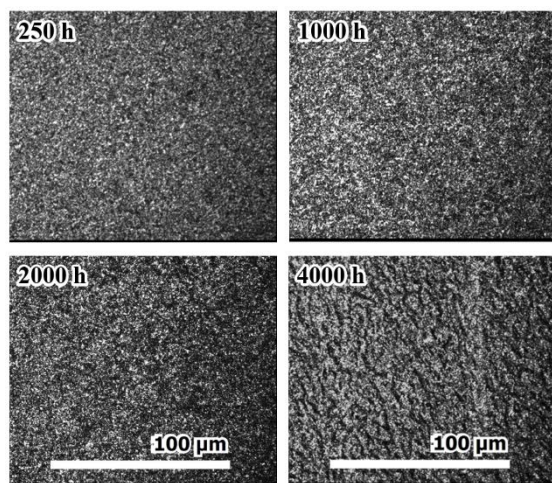
**Fig. 10.** LSCM images of the PPE outer layer surface after various times of exposure.

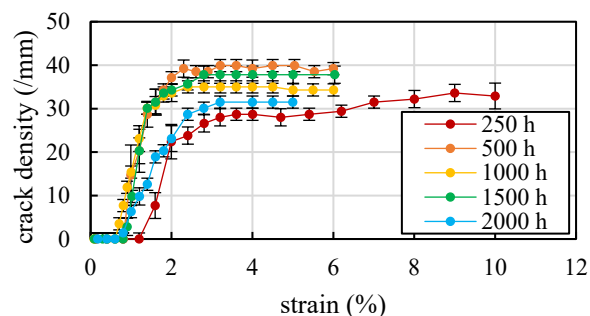
**Fig. 11.** Crack density as a function of strain in PPE after various exposure times.

Cracking behavior in PPE is similar to AAA, shown in Fig. 11. The fresh sample does not experience cracking. However, after 250 h of exposure, cracks begin to open after a critical strain is reached. Increasing the strain causes further cracks to open, until a saturation crack density is reached. However, some differences are observed between the two backsheets. At first, measurements after a longer exposure result in a decreased critical strain, the highest being observed in the shortest exposed sample. This trend reverses after 1000 h. A likely reason is the rougher surface due to degradation, which makes it more difficult to identify newly formed thin cracks. This effect is especially strong in the 3000 h and 4000 h exposed samples, which are impossible to evaluate using the LSCM, and are thus not included in this analysis.

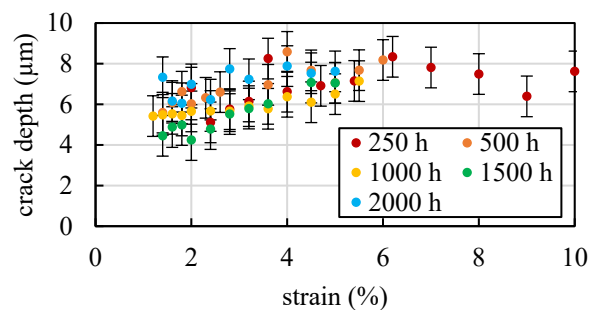
**Fig. 12.** Maximal crack depth in PPE after various times of exposure at different strain.

The crack depth only slightly increases with a higher applied strain. Furthermore, there is no correlation between the time of exposure and crack depth, seen in Fig. 12. This behavior may be caused by the weathering and erosion of the outer layer, as the most strongly degraded parts are removed over time. The maximal measured crack depth is  $(8.6 \pm 1.0) \mu\text{m}$ , observed in the 500 h-exposed sample.

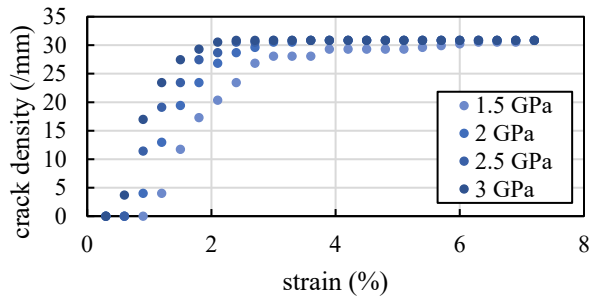
Fig. 13. Parameter variation of the modulus of the outer layer.

Before looking at the comparison between FEM model and measurements, we evaluate the influence of different parameters on the simulation results. Varying the properties of core or inner layer has no effect on the results. This can be explained by the boundary conditions in the fragmentation experiment, where a certain strain is applied on the entire backsheet. In fielded PV modules, this strain depends on the properties of all layers of the entire module, such as thermal expansion coefficients or moduli [25]. Varying the properties of the outer layer influences the simulations. A higher modulus leads to cracks opening earlier, as the decohesion criteria are met at a lower strain, shown in Fig. 13. Increasing the crack depth while keeping the saturation crack density constant can reduce the crack density at certain strains, shown in Fig. 14. As a crack opens, the stress on its sides is reduced, shown by one example in Fig. 15. This crack density reduction affects a wider area for deeper crack, causing the decohesion criteria of nearby possible cracks to have a later onset.

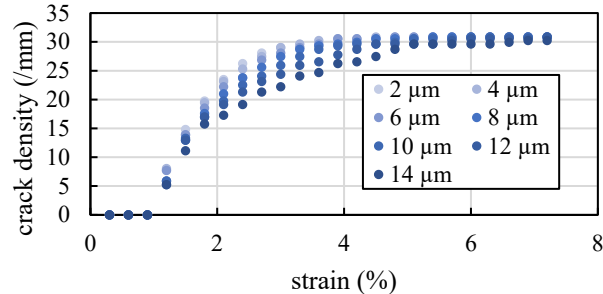
Fig. 14. Parameter variation of the crack depth.

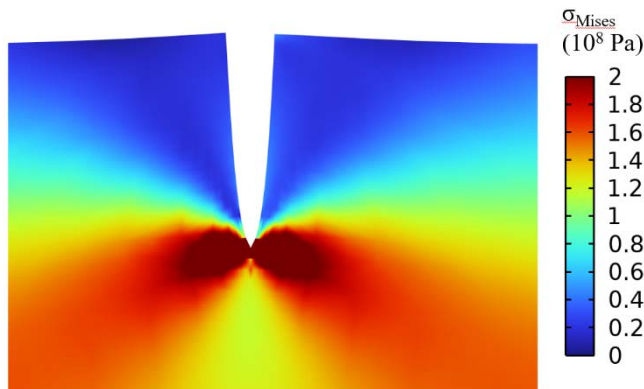
Fig. 15. Von Mises stress  $\sigma_{Mises}$  around a crack, with the visible singularity in the crack tip. The crack depth is  $14 \mu\text{m}$ .

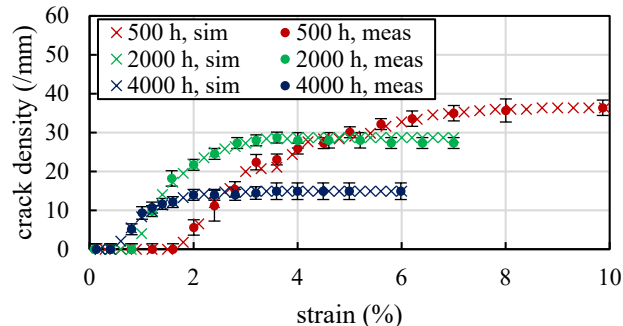
Fig. 16. Crack density in AAA in simulation and experiment.

The simulation model is, in general, able to fit the measured crack density in relation to applied strain with good accuracy and a low RMSE between experiment and simulation, shown by the example of AAA in Fig. 16 and by the example of PPE in Fig. 17. The corresponding parameters of the Weibull probability density functions are given in Table I, resulting in decohesion criteria in the unit of MPa. The optimized parameters are conclusive with the experimental results. In both backsheets, the initial increase in crack density with increasing strain is slower in the shortest exposed samples, seen in the higher  $k$ . In PPE both  $\lambda$  and  $\theta$  initially get smaller for longer exposed samples, indicating cracks formed at lower strains. However, the trend reverses after 1000 h of exposure as the PET outer layer surface degrades. While  $\lambda$  and  $\theta$  decrease after longer exposure in AAA, there is some larger variation of these parameters. Within certain limits both  $\lambda$  and  $\theta$  have a similar

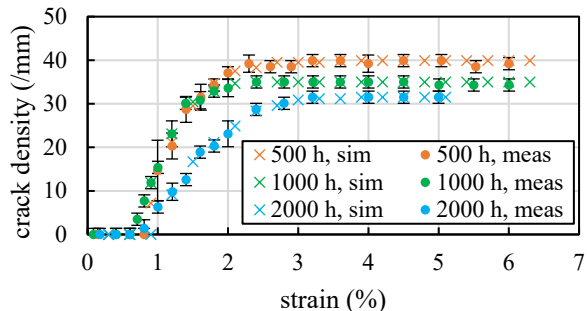
Fig. 17. Crack density in PPE in simulation and experiment.
